# WATERTOWN ARSENAL LABORATORY

NO. WAL 710/520

Heavy Tank T26E1

Metallurgical Examination of Components Which Failed

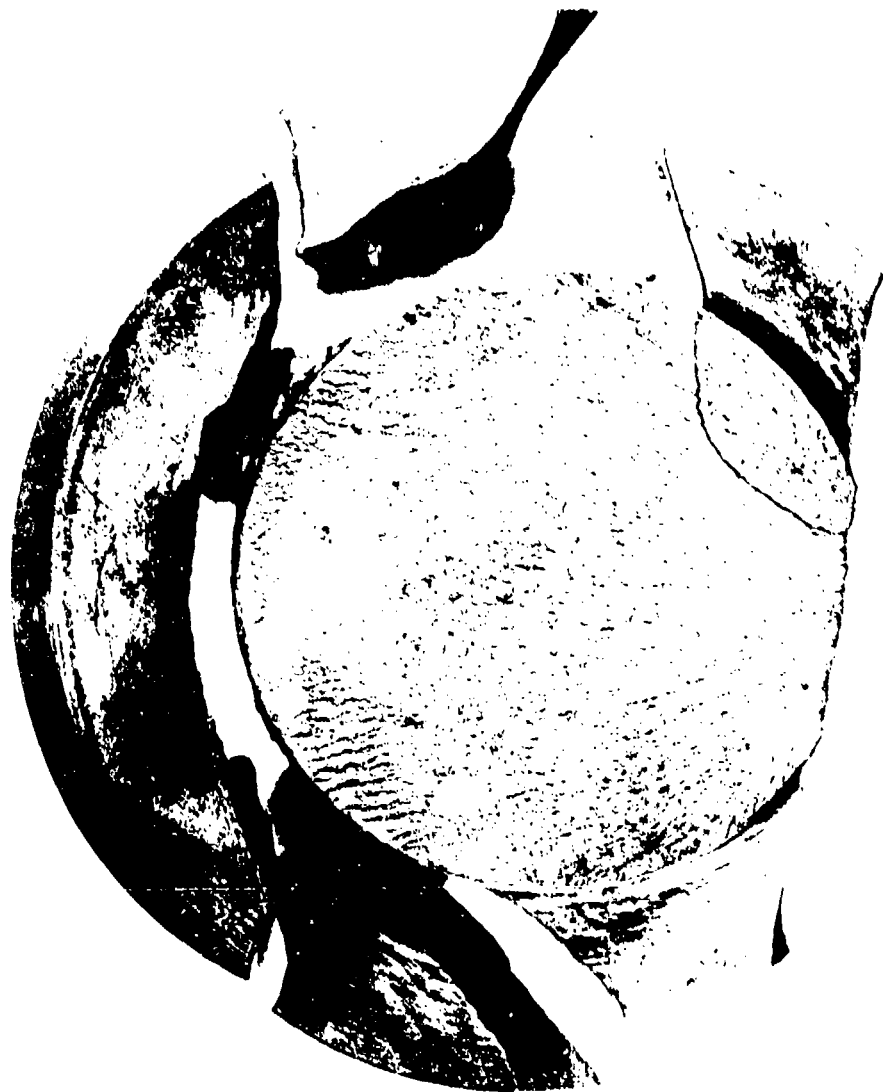
FIGURE 1

The shattered positions of the shaft which were submitted, see Figure 1, exhibit crystalline fractures throughout. The fracture appeared to have been initiated at the fillets on both sides of the flange.

14 AUG 1944      TRUNKION PIN NO. 8337185      MTN. 720-730

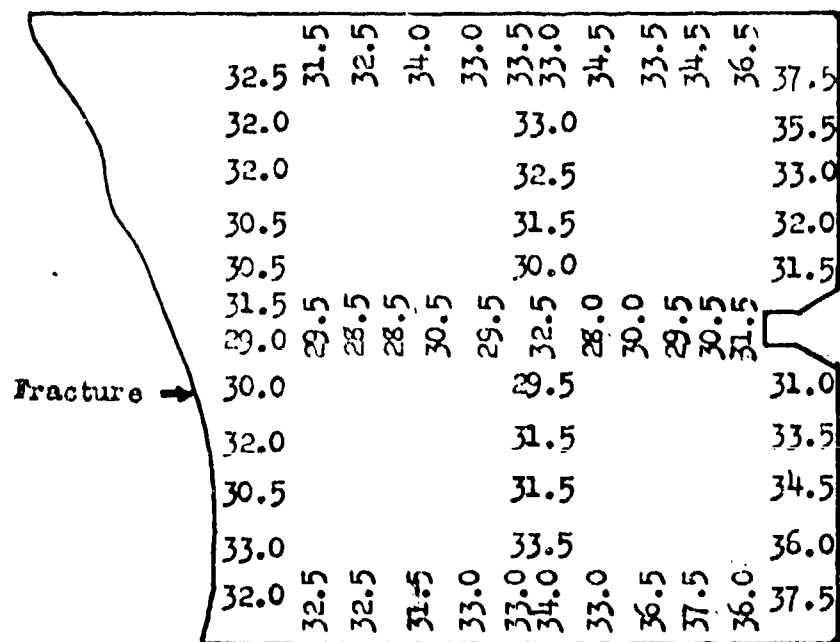
Rockwell C Hardness Results on  
Cross Section of Trunnion Shaft

Rockwell C hardness tests were conducted on a ground cross section of the fractured half section submitted. The hardness varied from Rockwell C 36 (332 Brinell) at the end to Rockwell C 29 (276 Brinell) at the center of the shaft, see Figure 2. The hardness of the flange was Rockwell C 41 (382 Brinell). In view of the wide variation in hardness obtained, it is obvious that the trunnion was not properly quenched hardened. The hardness at the center was considerably lower than the 363 to 415 Brinell specified on the engineering drawing. The trunnion would be expected to withstand a great deal of punishment without deforming at a hardness level of 330 to 360 Brinell providing it was properly heat treated. Heat treating the trunnion to hardnesses over 360 Brinell is undesirable since the impact strength even after optimum heat treatment drops to 15-25 ft. lbs.

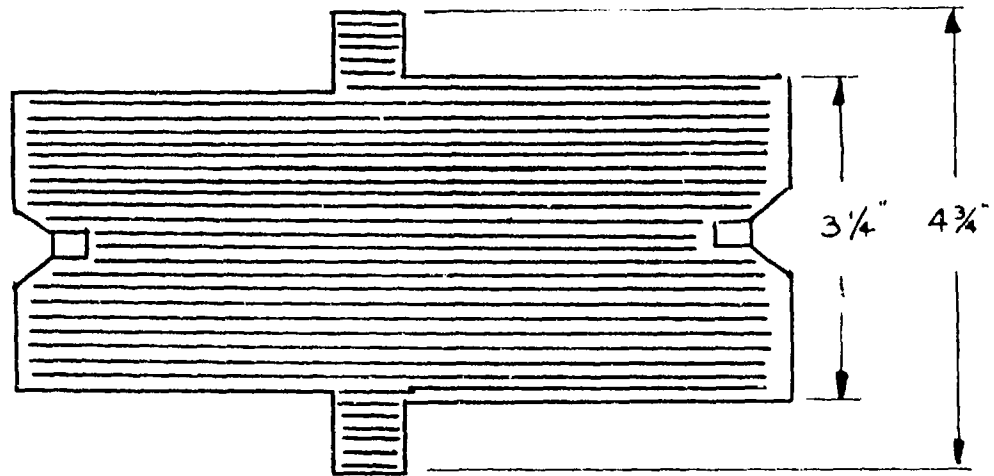
Present Design of Trunnion Shaft  
Made from Bar Stock

7. The trunnion shaft was subjected to severe impact stresses in the transverse direction under the ballistic impacts which exerted a large rotational force on the turret. The large inertia of the gun mount opposing the freely moving turret was transmitted through these trunnion shafts. Consequently the shaft was subjected to high impact stresses which were a maximum at the base of the flange. Since the shaft studied possessed poor impact strength, the ballistic attack resulted in a brittle fracture which was initiated at the base of the flange.

GRAIN FLOW IN TRUNNION SHAFT  
(Cross Section Views)
